# Pipe Repair Strategies on I-29

Research Advisory Committee 2012

NDDOT- Materials and Research Division

- In the Fargo District
- Along Interstate 29 RP 75, North Bound

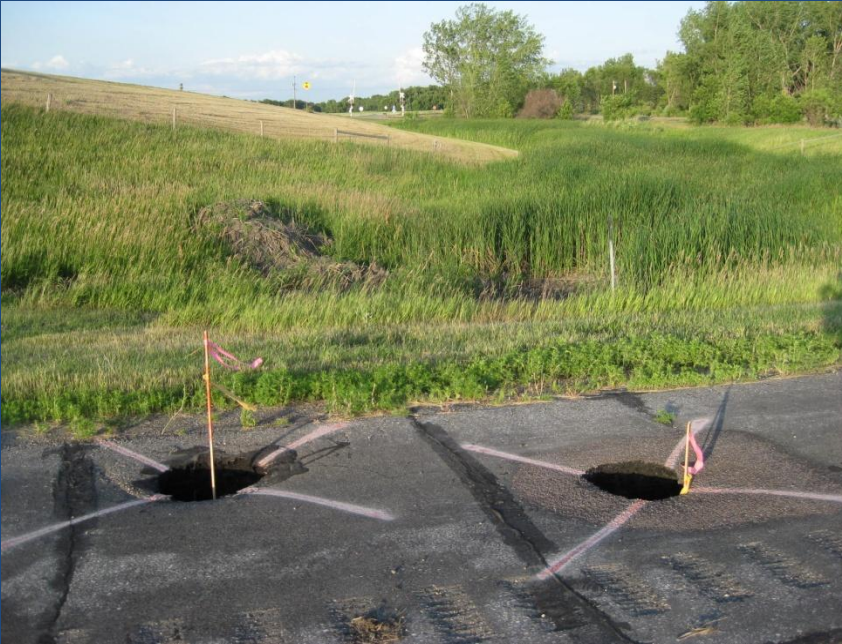
- Voids in shoulder

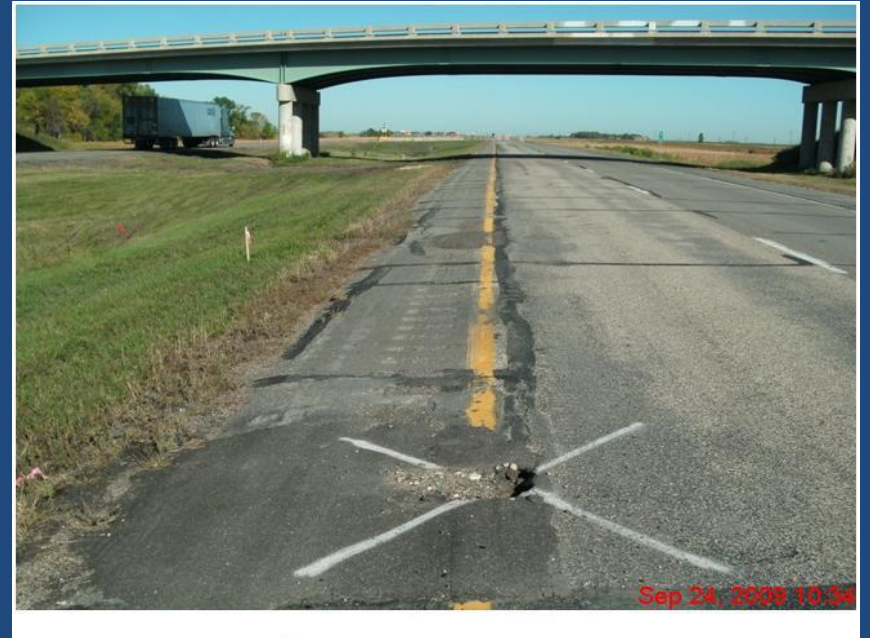
- Voids in passing lane

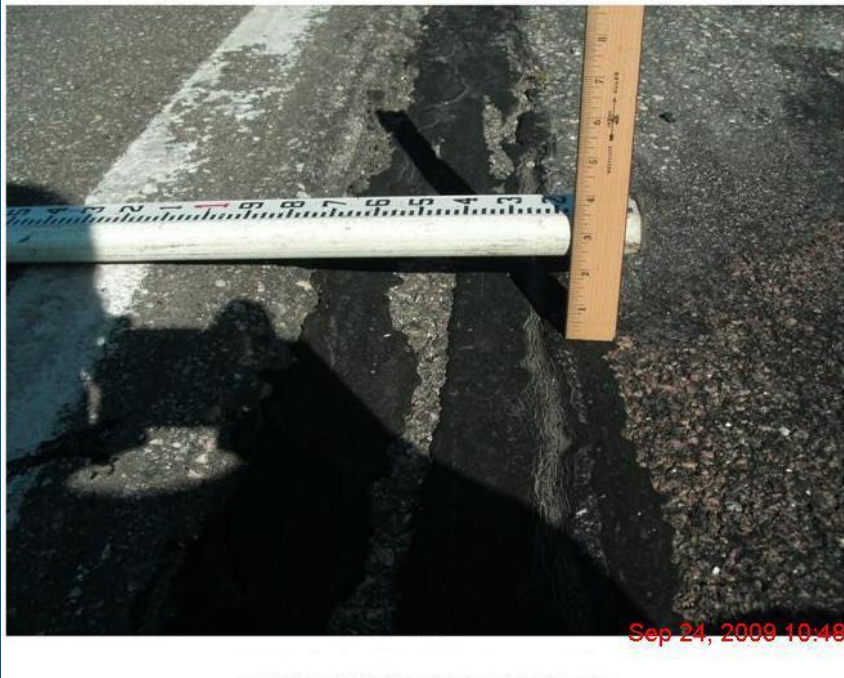
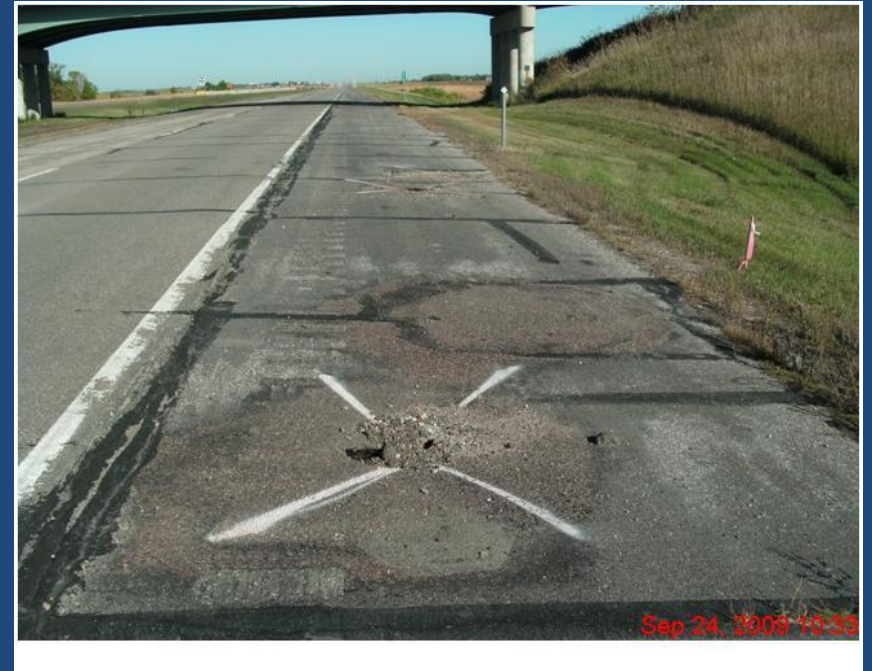
- Shoulder settlement
- Void had been filled with gravel

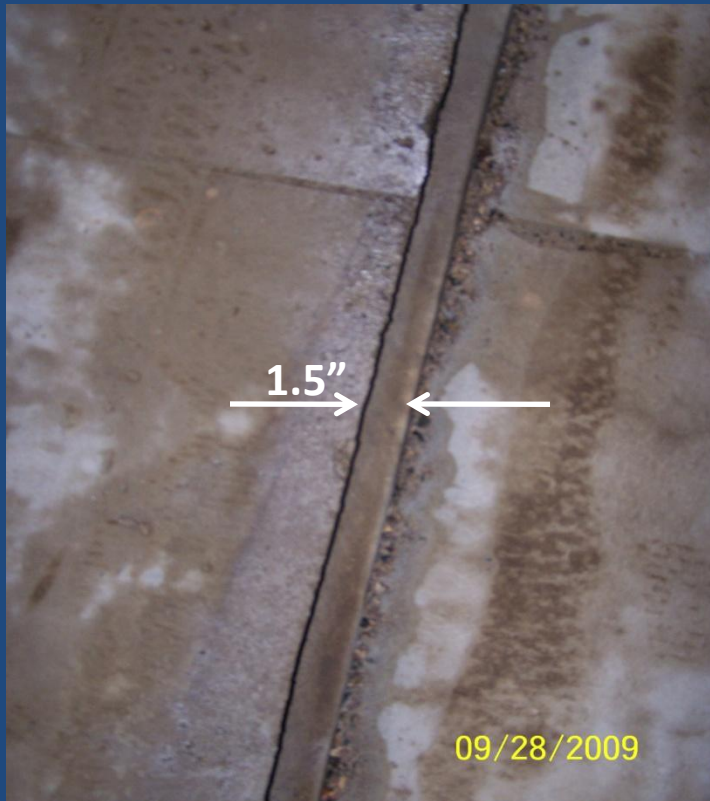
- Separated Joints

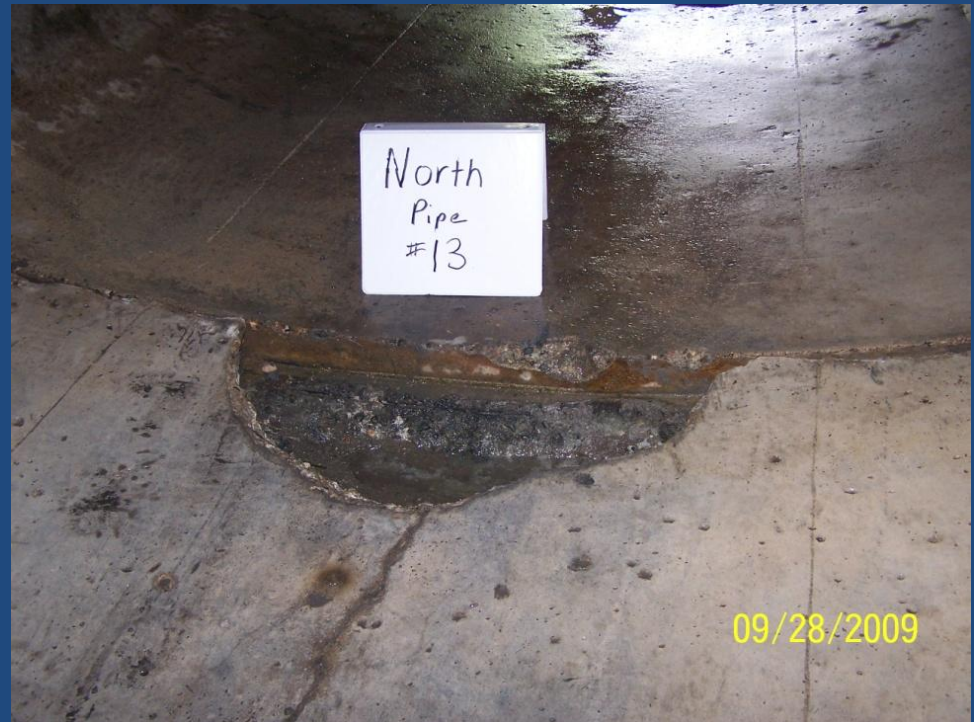
- Deteriorated concrete at pipe joint

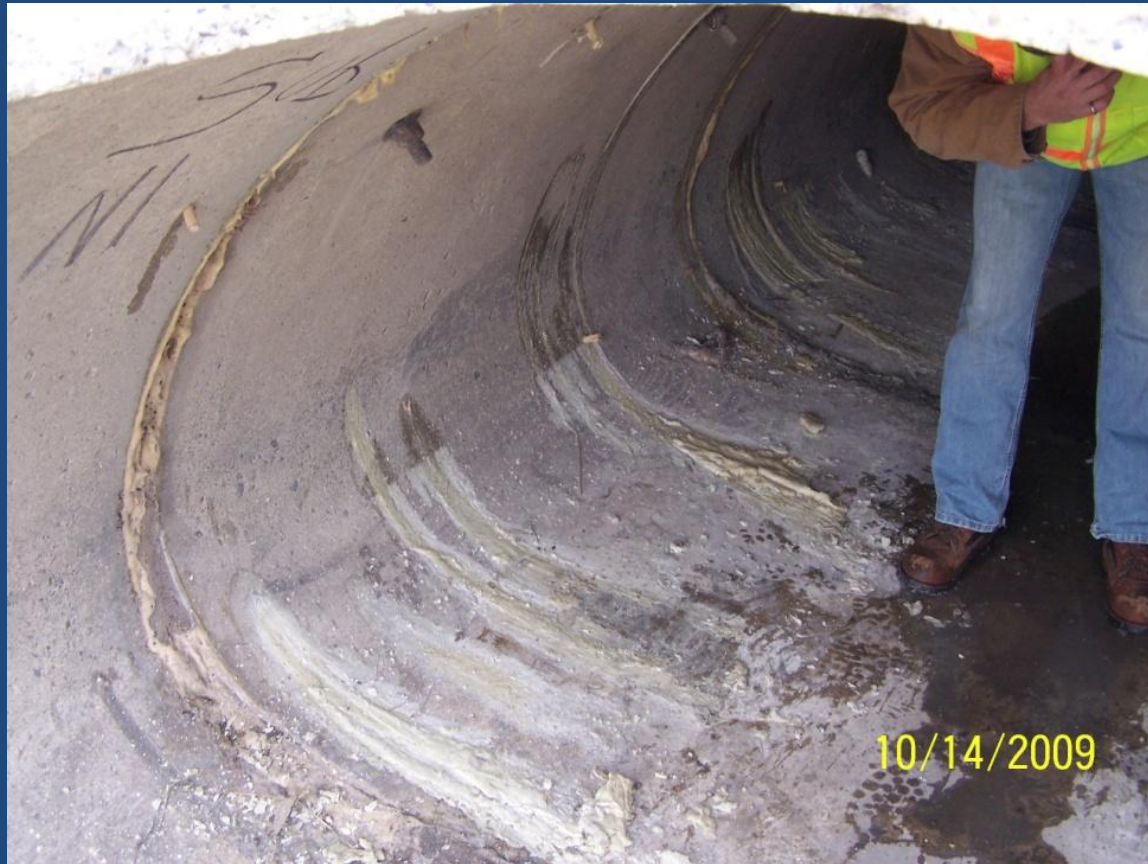
- Flexible foam soaked oakum with injection worked well but a surface epoxy is recommended for longevity.
- Rigid foam did not fill some voids under the pavement.
- QuakeWrap application requires the joint to be aligned and sealed before installation and is labor intensive.
- Internal pipe ties were effective to prevent movement.

- Injected Rigid Foam behind RCP

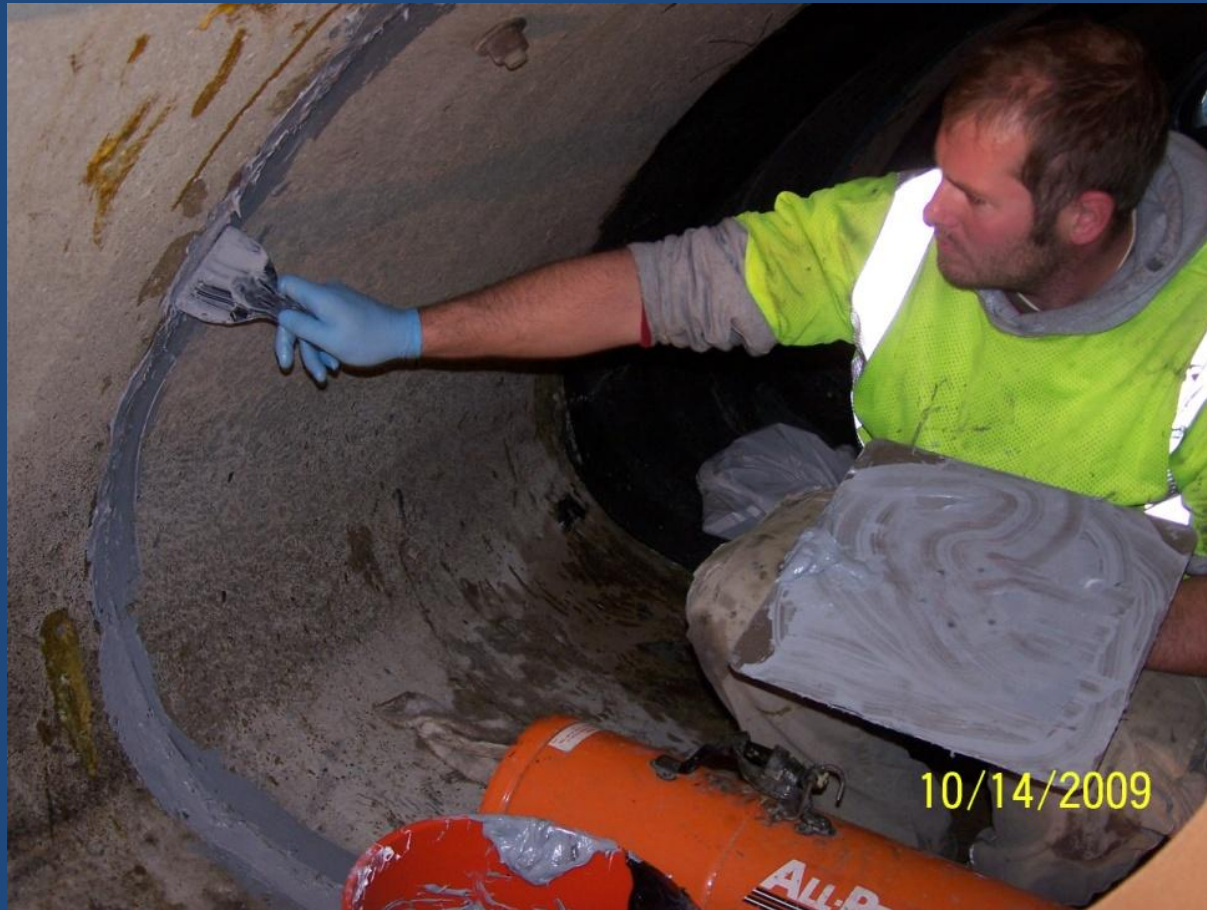
# Placing Surface Epoxy

- All joints remained sealed
- Minimal deterioration of mortar patches
- Epoxy did not adhere well to concrete in some areas
- No signs of pipe movement
- Hard to address all embankment voids during repair

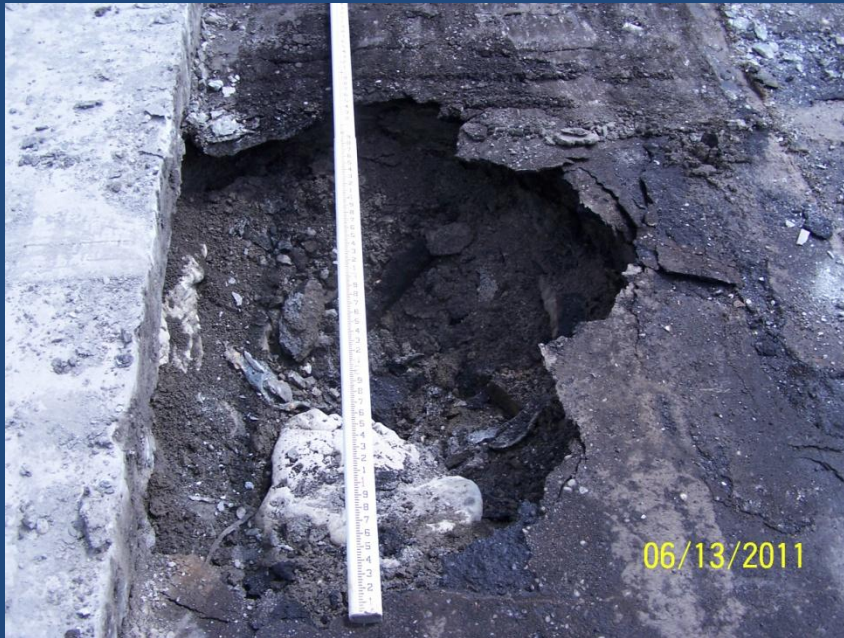
#1 some structural foam

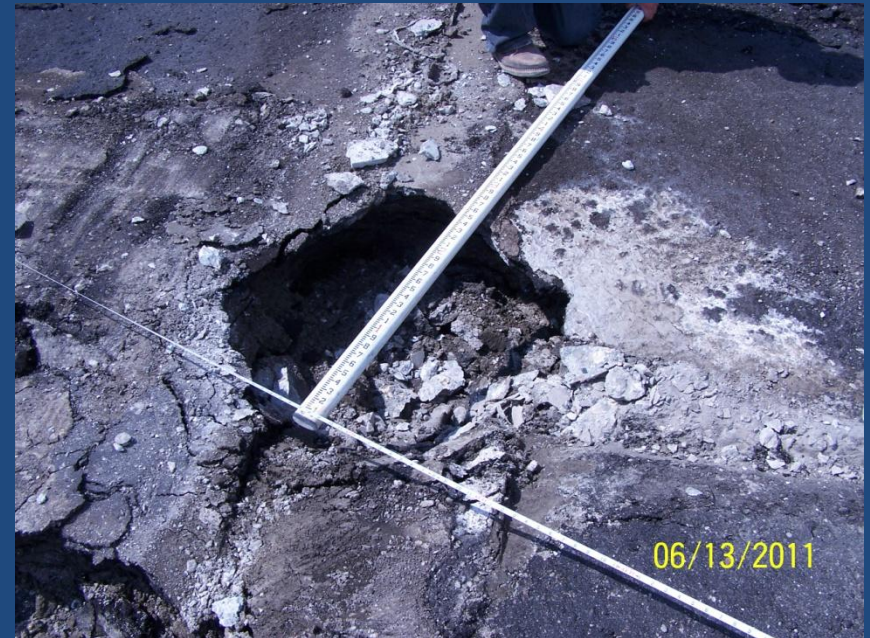
# 2 no structural foam

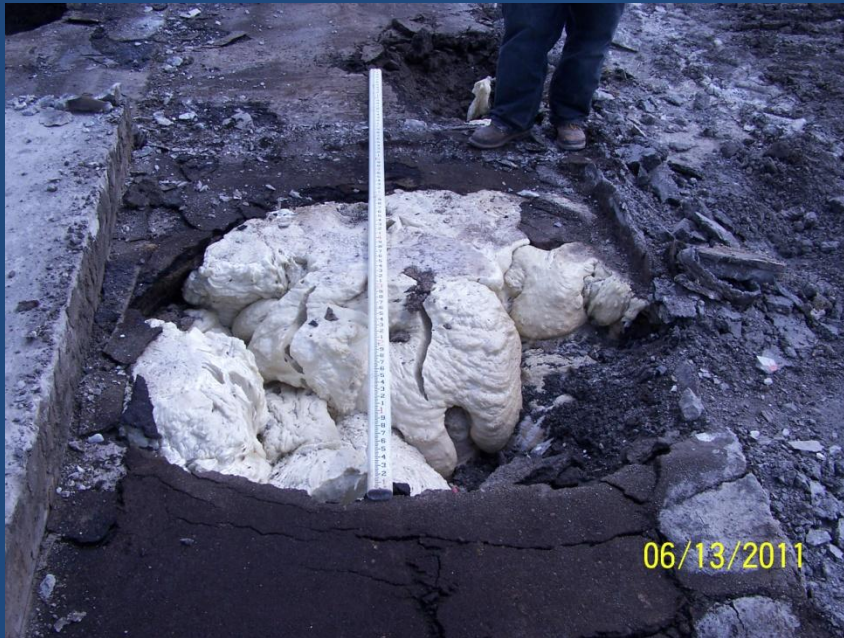
**#3  $\frac{3}{4}$  full of structural foam**

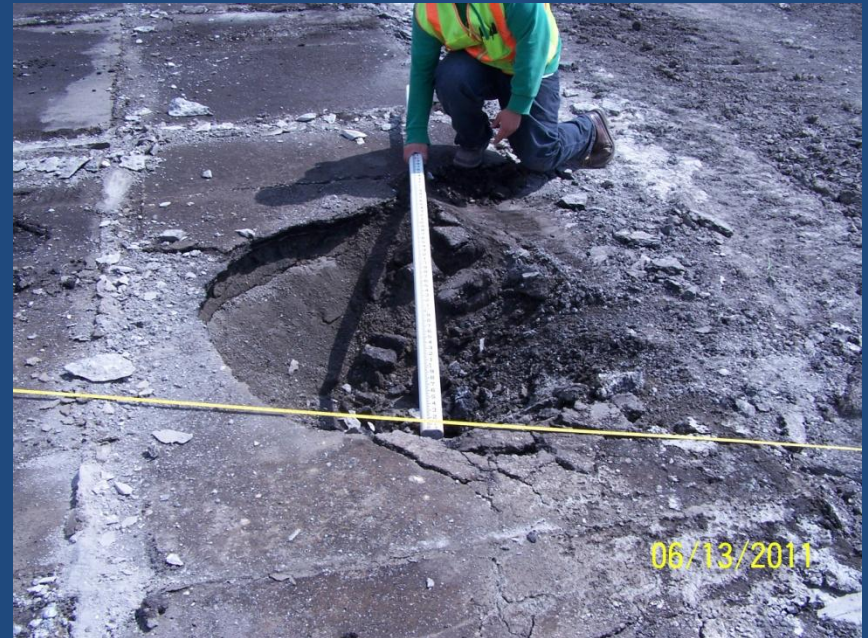
**#4 no structural foam in void**

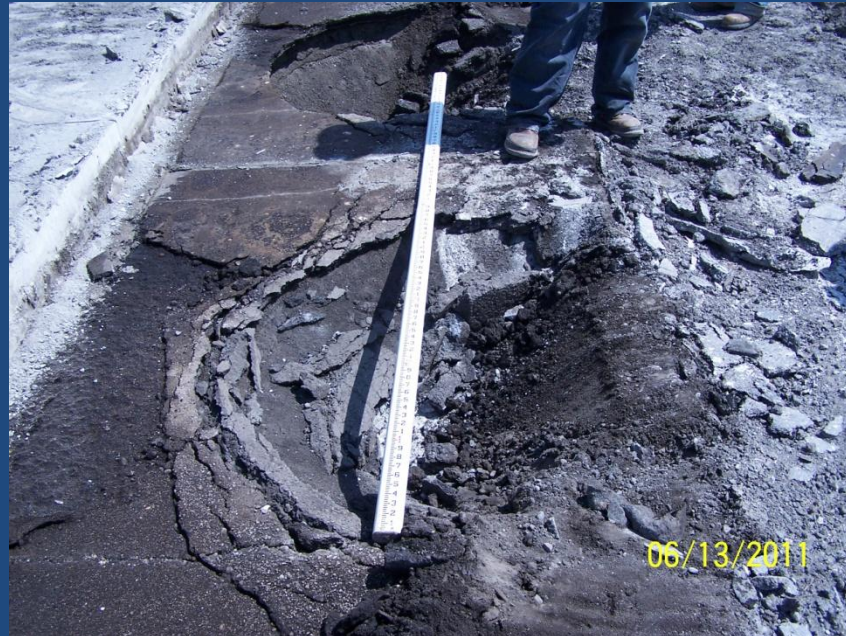
**#5 no structural foam in void**
